Mullor Gearcase
Industry: Foundry
Case Study No. 81544

Analytical Ferrography Provides Early Warning of Mullor Gearcase Failure

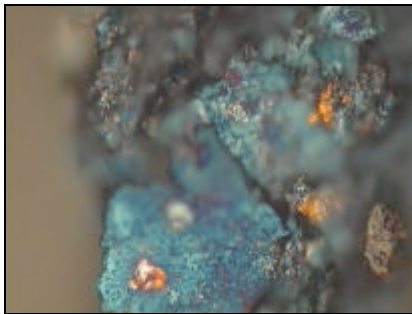
An oil sample was sent to Trico on October 31, 2002 for analysis. This revealed the generation of extremely large gear and bearing wear particles.

Figure 1. Low Alloy Steel Gear and Bearing Wear Particles by Analytical Ferrography

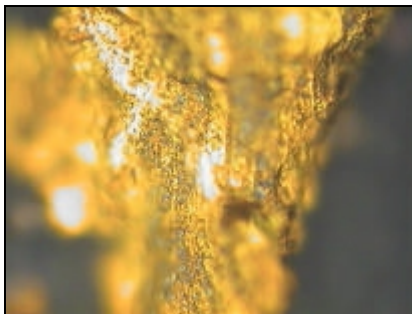
Figure 2. Copper Alloy Metal Bearing Wear Particles by Analytical Ferrography

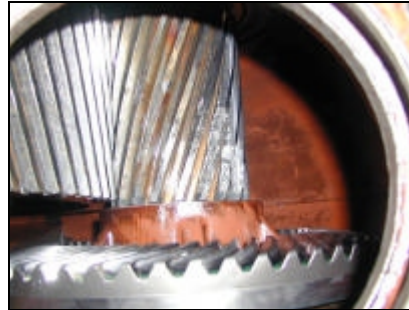
The inspection of the unit revealed a pinion gear starting to disintegrate.

Figure 3. Pinion Gear

The oil was drained from the unit and all the debris was thoroughly flushed from the gearcase. The unit was then filled with new oil. Operation resumed under close watch until a replacement gearcase was secured and installed.

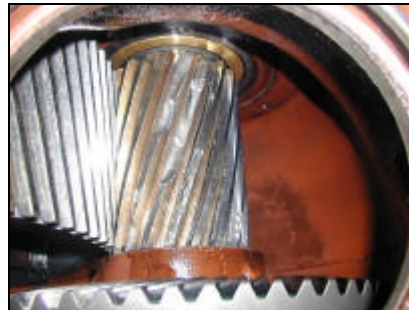
Figure 4. Disintegrating Gear

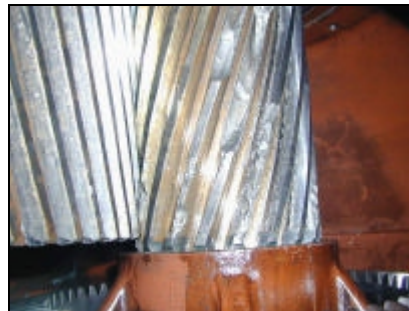
Figure 5. Close-up of Gear

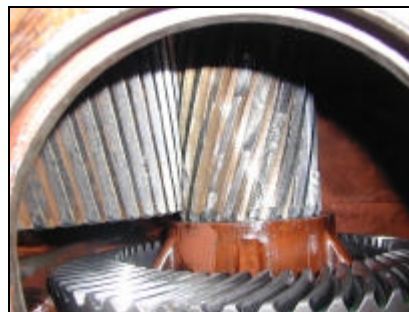
Figure 6. Alternate Close-up
