Power Condensate Pump  
Industry: Power Plant  
Case Study No. 37308

## CASE STUDY

### Further analysis prevents equipment shutdown.

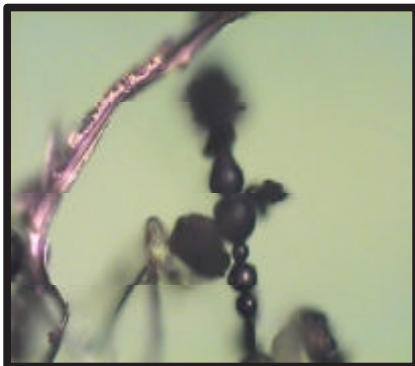
Figure 1

Upon examination of the ferrogram (wear particles deposited upon a glass slide for evaluation), fatigue spheres were observed (as seen in Figure 1).

Fatigue spheres are often indicative of bearing fatigue prior to a spalling condition, which are generated in the bearing fatigue cracks.

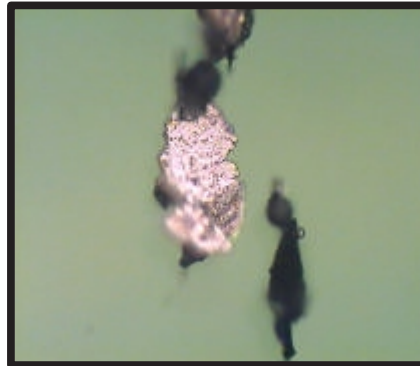
Figure 2

Accompanying the fatigue spheres were high alloy steel bearing wear particles (as seen in Figure 2).

Bearing wear particles indicate rolling contact failure due to improper load, speed, and/or poor lubrication of equipment's mating surfaces.

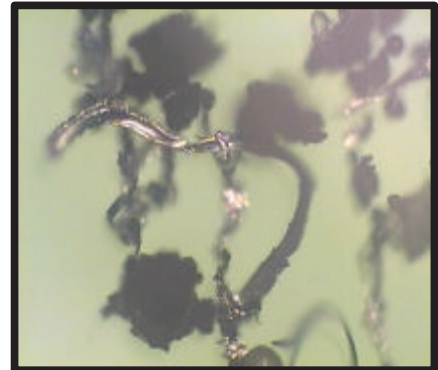
Figure 3

Severe sliding wear is generated due to excessive speed and/or load on surfaces in contact. Cutting wear (as seen in Figure 3) is an indication of abrasive particles in this lubricant.

The continued presence of these large particles indicated that a CRITICAL wear mode was in progress and maintenance was required.

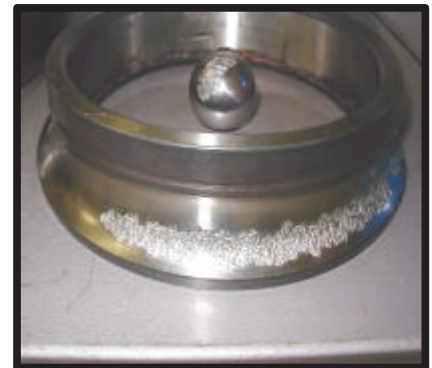
Figure 4

An inspection was performed on this pump and showed spalling of the inner race and rolling elements (as seen in Figure 4).

The timely identification of this failure mode minimized the repair cost to under \$10,000.00, with no secondary damage to the equipment. According to the customer, the motor was cleaned and reassembled with new thrust bearings and made ready for operation, savings \$80,000.
