# CASE STUDY

## Ferrography provides early warning of bearing failure, confirmed by vibration analysis.

The equipment being monitored is a General Electric Turbine Generator supported by journal bearings.

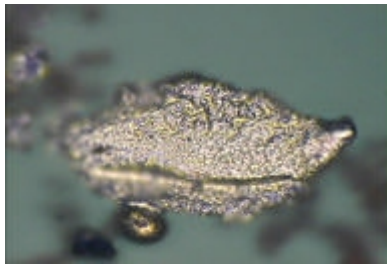
**Figure 1**

Upon examination of the ferrogram (wear particles deposited upon a glass slide for evaluation), babbitted material was identified (Figure 1). The babbitted particles were measured to 90 microns in size. The quantity of these particles observed was rated moderate to high. The size and quantity of particles present indicated a critical wear mode was

Used oil analysis showed acceptable results. Viscosity, FTIR, and spectrographic analysis were all normal with no indication of any wear or lubricant related problems. The reason spectrographic analysis failed to detect the current wear mode is it's inability to analyze particles over 8 microns in size. Babbitted particles are generated in larger pieces due to the physical properties of the material.

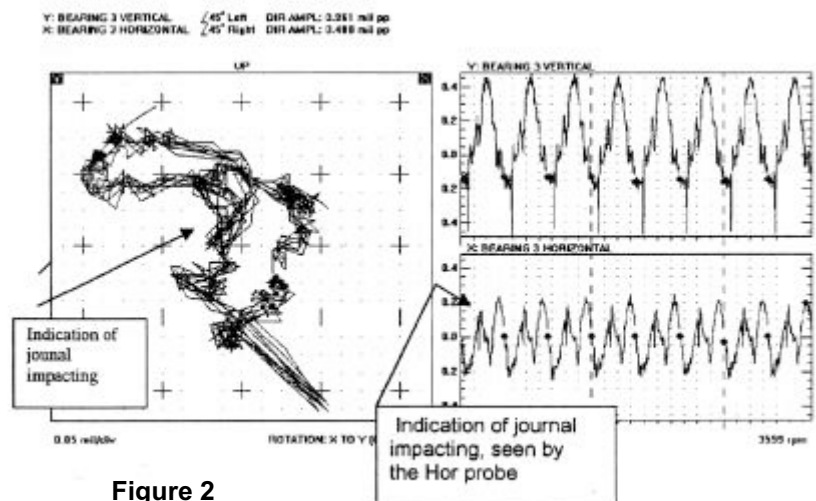
**Figure 2**

Journal #3 was identified through the vibration analysis as the bearing in the failure mode. The following vibration results were reported.

- Journal #3 is impacting a non-rotating element at the 7 o'clock position (Figure 2).
- The journal lift on the oil film shows only 2 mils lift. This indicates restricted or damaged bearings and/or seals.

- Journal lift plot shows the journal is moving to the left side of the bearing as observed from the turbine end. Journal movement should be to the right.
- Vibration response of journal #3 is very low as indicated by the bode plots performed.

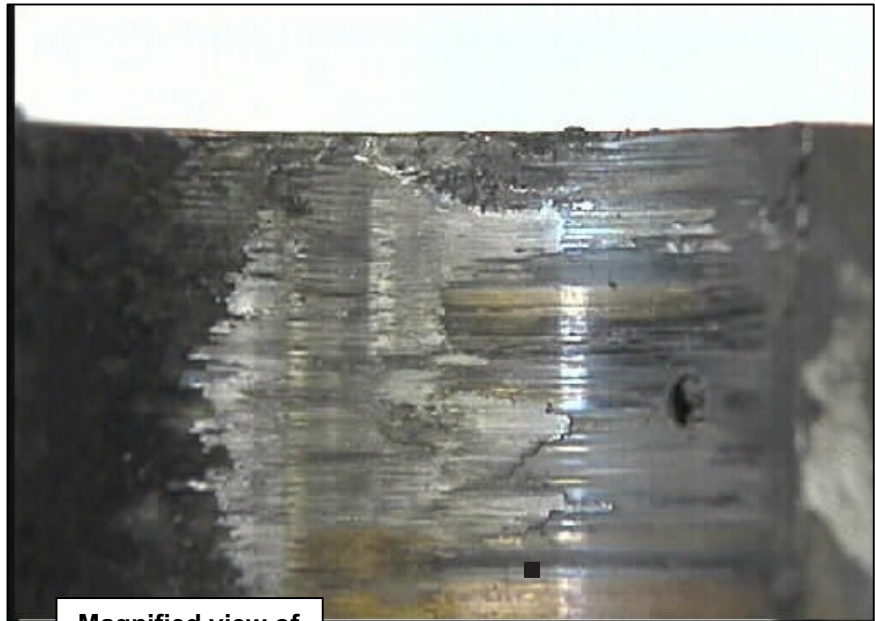
An inspection of this unit showed a wiped bearing. The timely identification of this failure mode saved our customer \$100,000.00.

**Magnified view of bearing surface**
