Diesel/Engine
 Industry: Mining
 Case Study No. 80050

Spectrographic Analysis provides early warning of a Diesel Engine failure

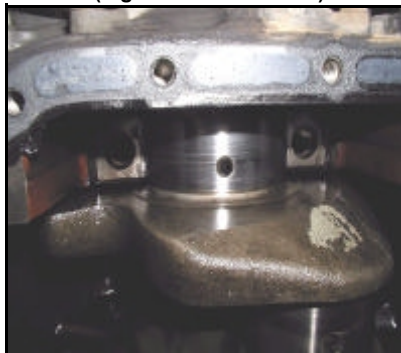
(Figure 1 Main Journal)

Elevated contaminant levels indicated a problem (illustrated in red). Inspection revealed one filter loaded and the other collapsed due to excessive amounts of dirt contamination.

Inspection of this engine identified severe damage applied to several of the components in this unit. The wear is depicted in these photos.

The timely identification of this failure mode minimized the repair cost to \$15,000.00. If not identified, the entire engine would have failed, increasing the cost to an estimated \$50,000.
