CONDITION REPORT

Equipment Specific Analysis

LOCATION ID: 2 Conv GBX
 DESCRIPTION: BXY
 COMPONENT: Gearcase
 LUBRICANT: Mobilgear 600 XP 320
 RESERV. CAP: 80 Gallons
 LUBE TIME: 0 Hours
 TEST SUITE: ABC

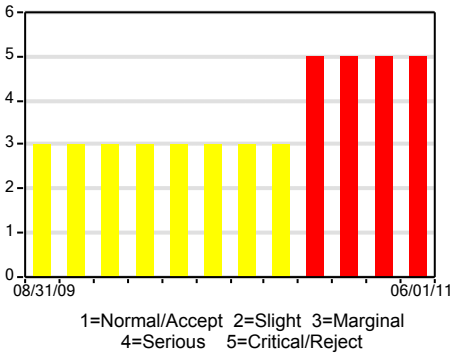
Rating

Sample Date	03/02/2010	07/27/2010	01/07/2011	02/01/2011	03/01/2011	04/03/2011	06/01/2011
Ratings	Marginal	Marginal	Marginal	Critical	Critical	Critical	Critical

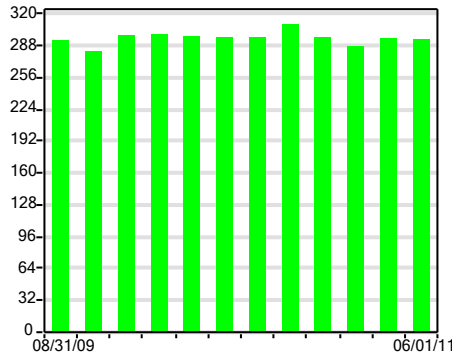
Viscosity (40C)

03/02/2010	07/27/2010	01/07/2011	02/01/2011	03/01/2011	04/03/2011	06/01/2011
Visc 40C, cSt	296.39	295.91	309.14	296.53	287.35	295.09	293.86
Visc 100C, cSt

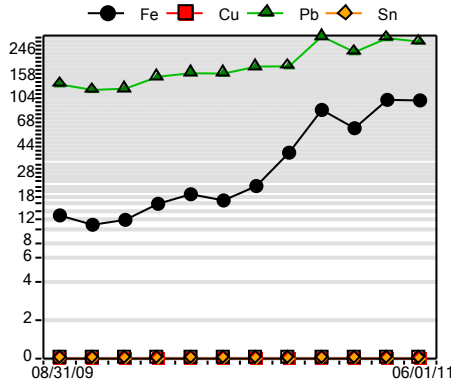
Wear Metals in ppm

03/02/2010	07/27/2010	01/07/2011	02/01/2011	03/01/2011	04/03/2011	06/01/2011
Iron	17	22	40	86	62	103	102
Chromium	0	0	1	1	1	1	1
Aluminum	1	1	0	1	0	1	2
Copper	0	0	0	1	0	0	0
Lead	165	187	188	321	242	311	292
Tin	0	0	0	0	0	0	0
Silver	0	0	0	0	0	0	0
Nickel	0	0	0	0	0	1	1
Silicon	7	6	3	9	4	10	9
Sodium	2	3	3	6	5	6	6
Potassium	2	1	0	0	0	0	3
Boron	0	1	0	1	0	1	1
Molybdenum	0	0	0	1	0	0	1
Magnesium	1	1	0	1	1	1	1
Calcium	12	14	12	26	20	23	26
Barium	0	0	6	2	0	6	0
Phosphorus	119	171	202	222	124	295	151
Zinc	2	2	2	2	1	3	2
Cadmium	0	0	0	1	0	1	0
Vanadium	1	0	0	0	0	0	0
Titanium	0	0	0	0	0	0	0

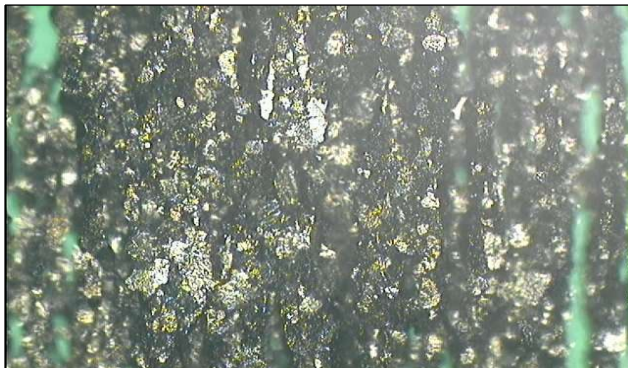
Image # 1 200X

The wear particle concentration increased from 210.0 to 428.0, and is now of concern. The large abnormal wear particles detected in the previous sample are no longer present. However, there are also increased amounts of wear debris, dirt, corrosive wear (oil additive depletion and acidic lubricant), and amorphous residue (degradation) contamination seen in this sample. This unit will remain at a CRITICAL rating based on the high lead level. Also note the abnormal wear rate and the presence of excess wear debris and contamination. Consider changing the oil in this unit.

This picture shows the excess steel rubbing wear debris and contamination observed in this sample.

This unit will remain at a CRITICAL rating based on the high lead level. Also note the abnormal wear rate and the presence of excess wear debris and contamination. Consider changing the oil in this unit.
